Tank AY-102 Leak Assessment

Dennis Washenfelder

November 7, 2012

Leak Assessment Conclusion

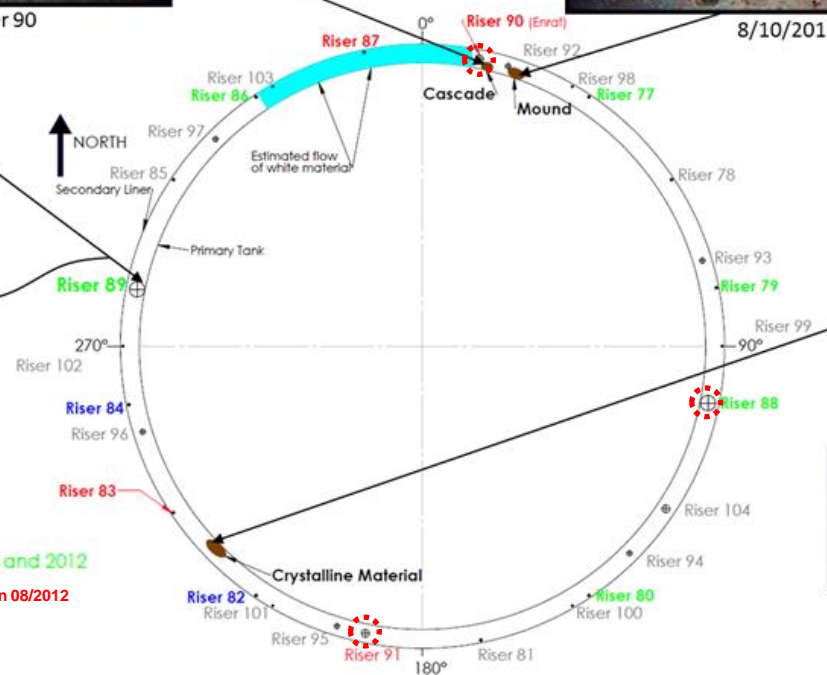
9/10/12 Riser 83

- Annulus Floor Material near Riser 83, September 26, 2012:
 - 45 mR/hr “Window Open”
 - Principal Chemical Constituents: NaNO_3 , Na_2CO_3 , NaNO_2 , KNO_3 ¹
 - Principal Radionuclide Constituents: Sr-90, 0.120 $\mu\text{Ci/gm}$; Cs-137, 90.9 $\mu\text{Ci/gm}$ (202 million disintegrations per minute per gram)
- Annulus Floor Material near Riser 90, August 10, 2012:
 - 800,000 dpm reading reported with detector near sample²

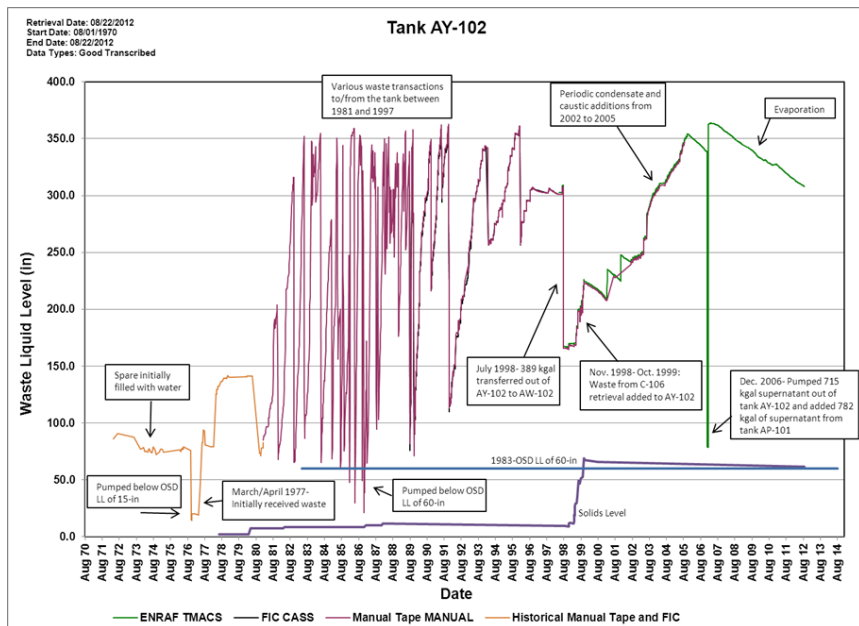
Liquid Level Changes

- Tank C-106 sludge retrieval during 1998 – 1999 increased the tank heat load by ~ 94,000 BTU/hr
- Since AP-101 transfer in 2007, evaporation rate has averaged ~ 77 gal/day, or ~ 28,000 gal/year
- **A small, episodic leak could occur undetected inside the evaporation rate**

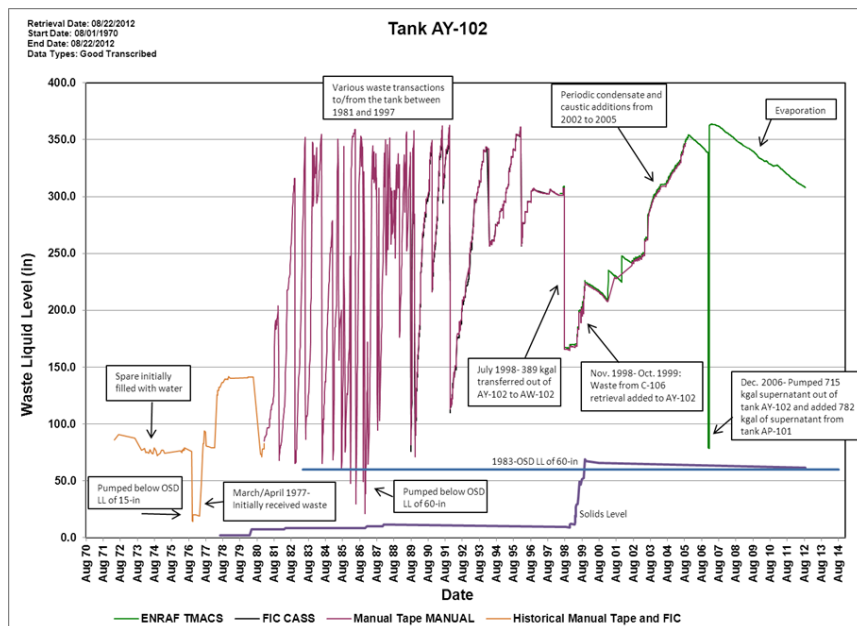
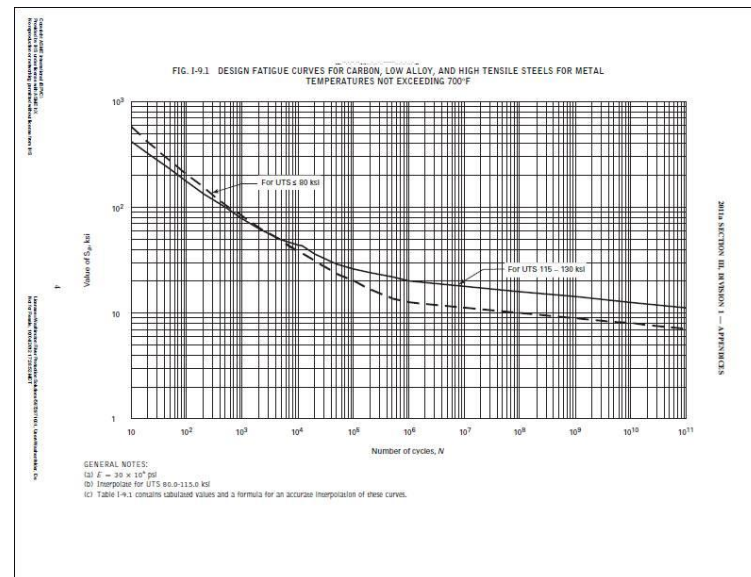
Fill Cycle Fatigue

- Cycle Fatigue evaluated in 1968 after structural modeling identified a region of the primary tank dome predicted to exceed minimum tensile stress.
- **Using ASME Section III Division I cycle fatigue guidance, safe cycles estimated to be 17,600**
- Backcheck using 2008 structural model results and 2010 version of code indicates ~ 25,000 safe cycles¹
